DRONE INSPECTION REPORT

07/31/2019

Hail

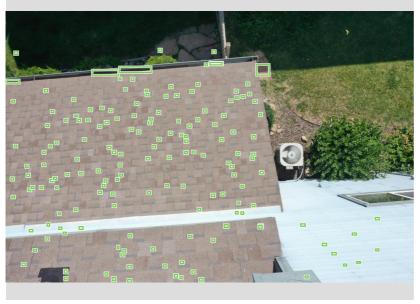
DC008

Confirmed Damage	Count
Hail Hit	140
Rust (beta)	9
Soft Metal Damage (beta)	14

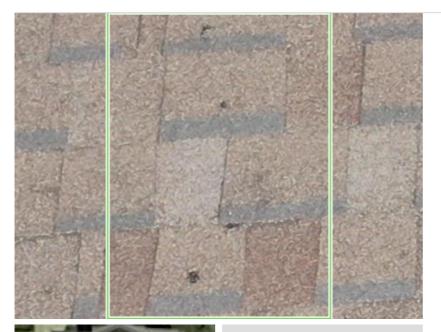
■ DC008-1 HAIL

Sample Hail Hits North West Slope

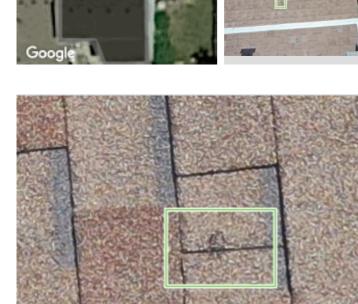
■ DC005-1 HAIL

Sample Hail Hit SE Slope

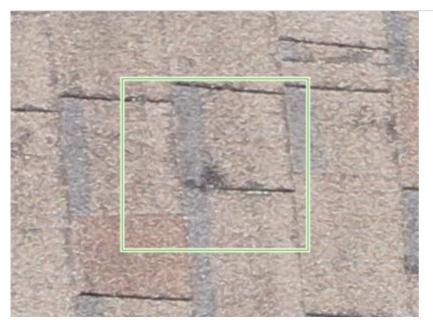
■ DC006-3 HAIL

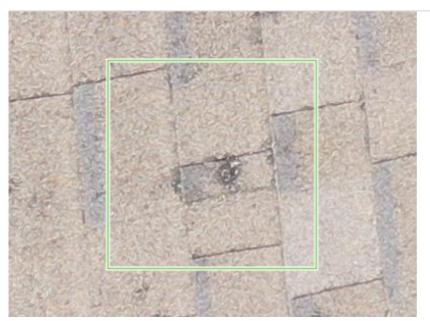
■ DC006-2 HAIL
